## **APPENDIX C – PlanGrid Task Report**

# PlanGrid Task Report - Aug 19, 2020

Prepared by James Holtom

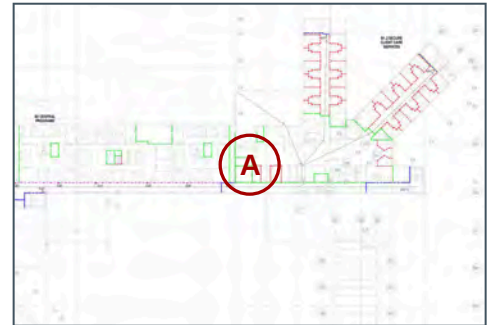
Flooring should have been replaced and not repaired

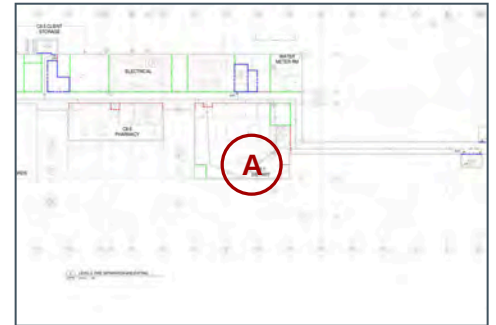
Pointless condition that collects dirt, possible infection control issue

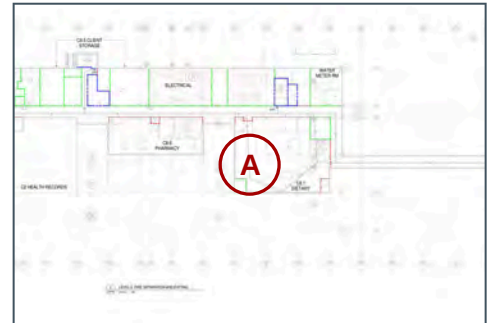
Loose floor plate cover, possible infection control issue

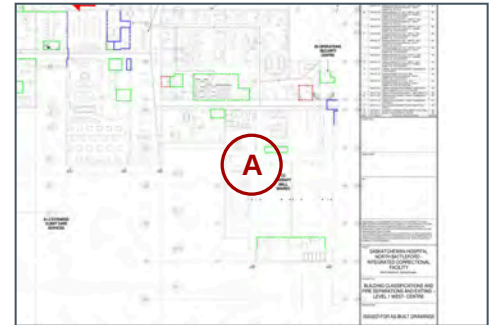
Missing fasteners at water fountains

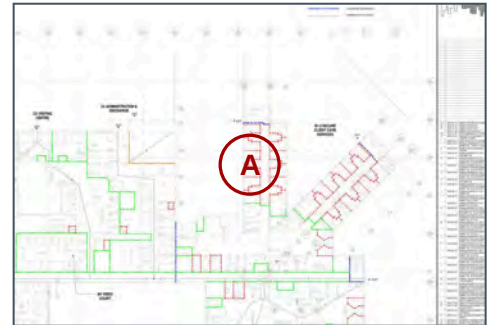
Wall imperfection will lead to waterproof failure

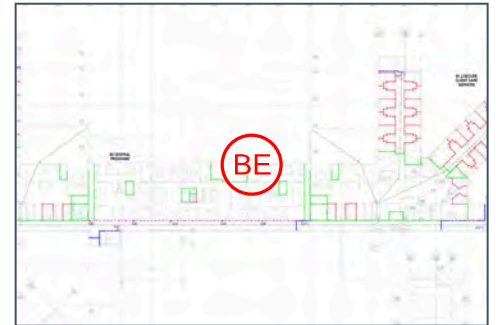
Exploratory hole near base of wall - daylight visible and draft indicating air leakage into wall cavity. Similar conditions likely exist all along this exterior wall based on thermal scans. Mould was also evident, as well as a small hole in the wall board.

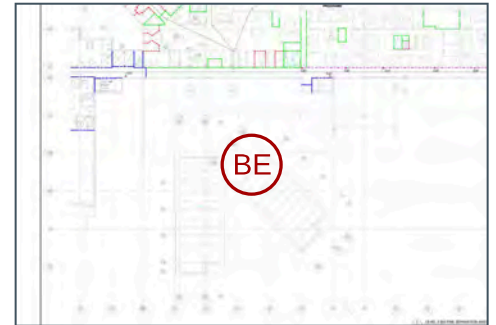
Air leakage between top of exterior wall and sloped roof, resulting in wet surfaces inside soffit. Frost also visible on exterior metal surfaces

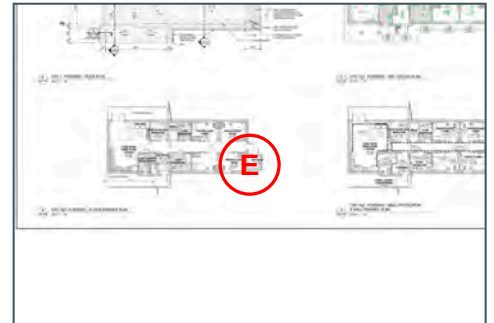
CRU-2: electrical enclosure box  
improperly cut to fit into space  
behind data rack

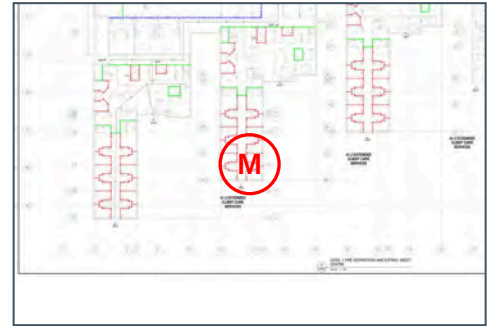
Vacuum toilet causes knocking noise. Pipe not appropriately secured and/or noise attenuation not sufficient through PVC pipe. Applies to entire wing.

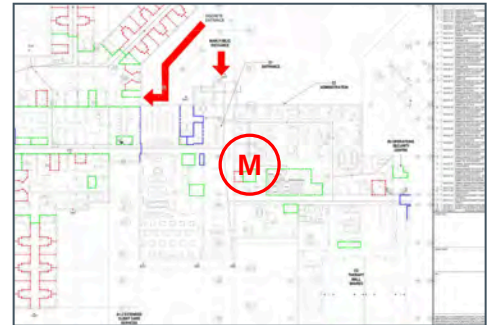
Leakage on duct main.  
Insulation ripped away.
