CROWN INVESTMENT CORPORATION
SASKPOWER SMART METER PROGRAM

ELECTRICAL
FIRE INVESTIGATION & REVIEW

Ritenburg &
Associates Ltd.
Consulting Electrical Engineers

October 24, 2014

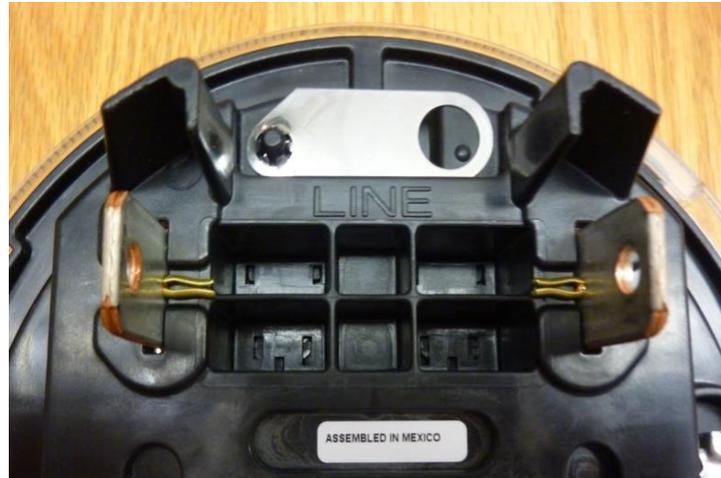
Figure 3: Holes in back facilitate mounting of various Sensus meter modules.

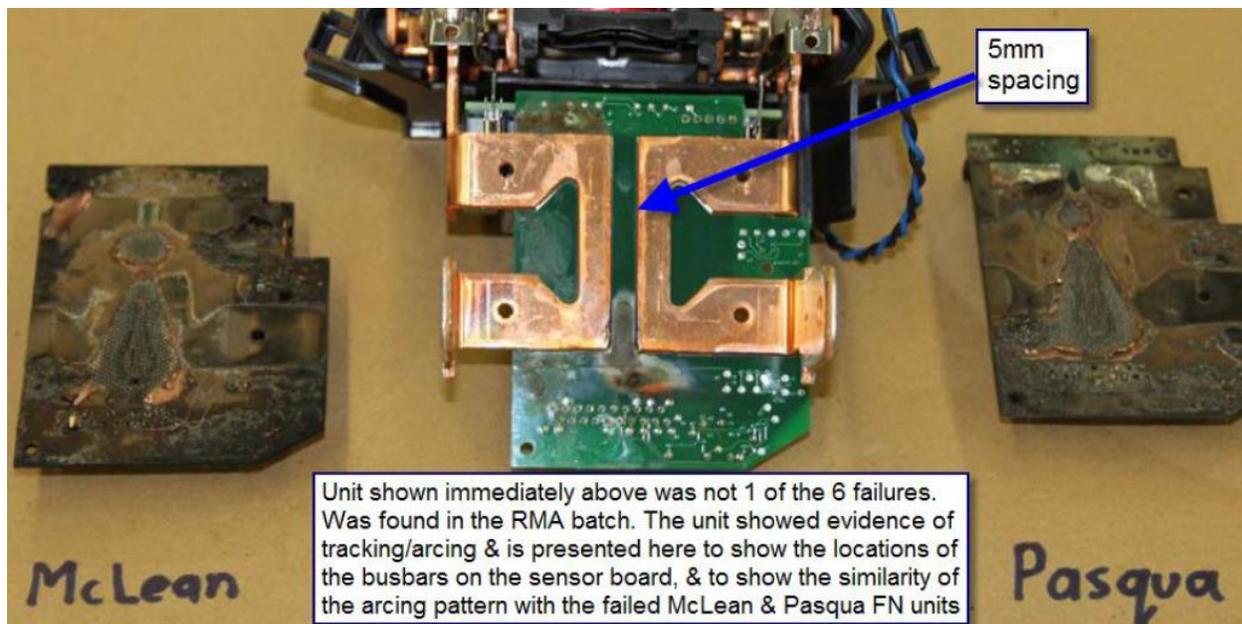
Figure 4: Comparison of burnt boards to RMA board. Source: SaskPower Preliminary Technical Report

The centre board shows clear evidence of arcing and tracking at the bottom of the bus that has resulted in a discoloration of the circuit board. On the left, the McLean board (#1) shows a similar pattern but has been damaged more. On the right, the Pasqua board (#5) shows a similar pattern but has been damaged more than the centre sample. The bus bars for both the McLean and Pasqua boards were vaporized in the destructive failure. However, the arcing and tracking pattern matches the sample.

SaskPower found that the McLean board had increased levels of calcium, magnesium and aluminum suggesting the presence of dust within the meter.

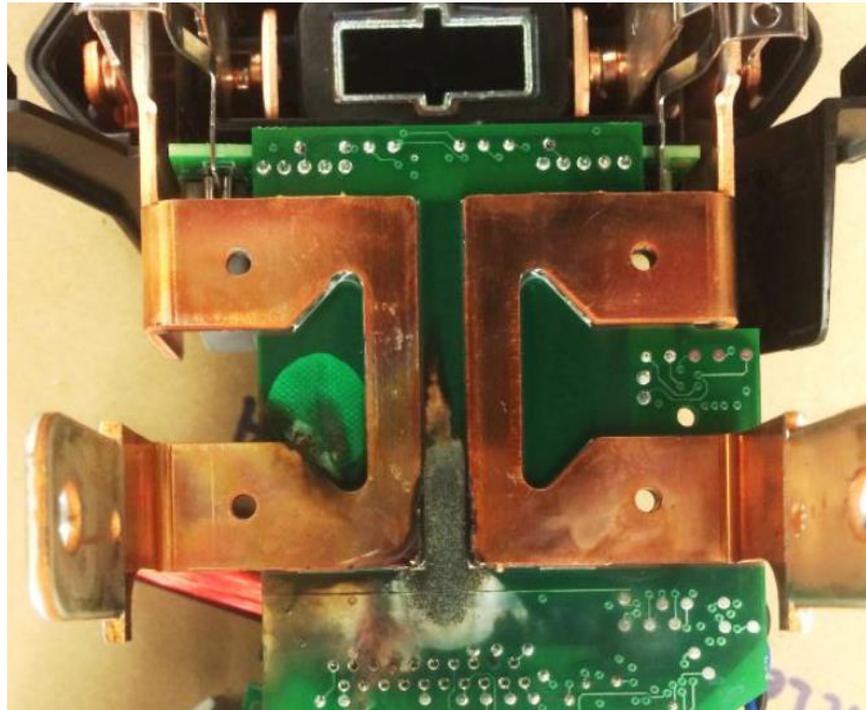
Figure 5: RMA Meter 997202 – Pilot Butte – Reported as meter display problem

The three meters shown above were returned for reasons other than arcing and tracking. These meters may have functioned for some time despite the arcing problem or the arcing problem may have caused the display to fail. We are of the opinion that there may be meters in service that have had arcing issues and even if the display has failed. The problem would not be apparent to SaskPower until the next manual meter read. Several months could pass before SaskPower would become aware of the problem.

There has been evidence of electrical tracking on the power boards of a number of meters that have been returned for other reasons, as described in section 2.3. Without further information, it is difficult to determine if this problem is more significant and involves larger numbers of meters. Furthermore, some of the electrical tracking and its symptoms could go unnoticed, caused by the large timeline between physical meter reads. There is a possibility that there are a number of working meters that were not part of any previous RMA and may have signs of arcing between the bus bars.

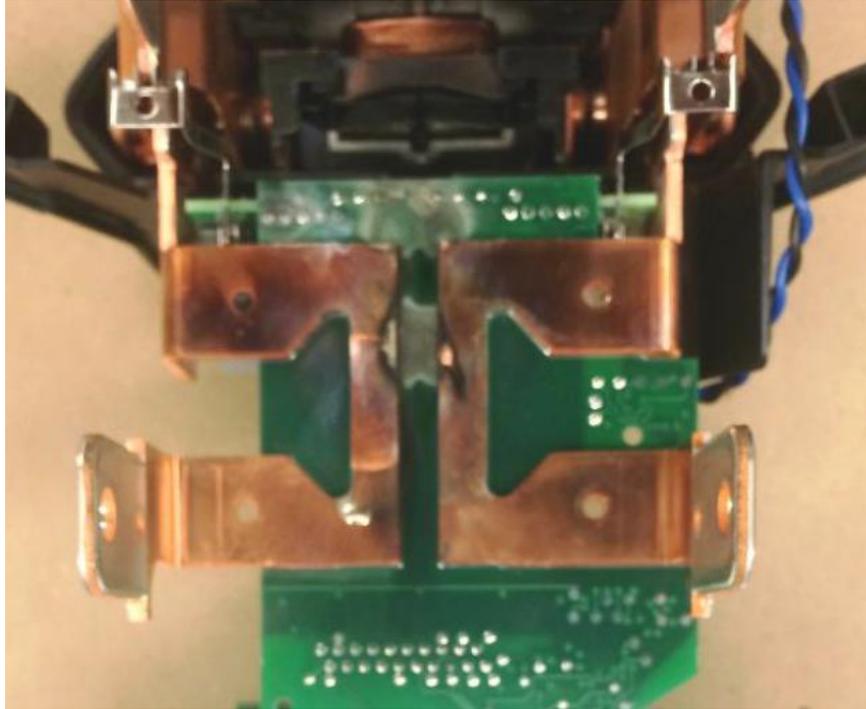
Figure 6: RMA Meter 998366 – Qu’Appelle – Reported as meter display problem

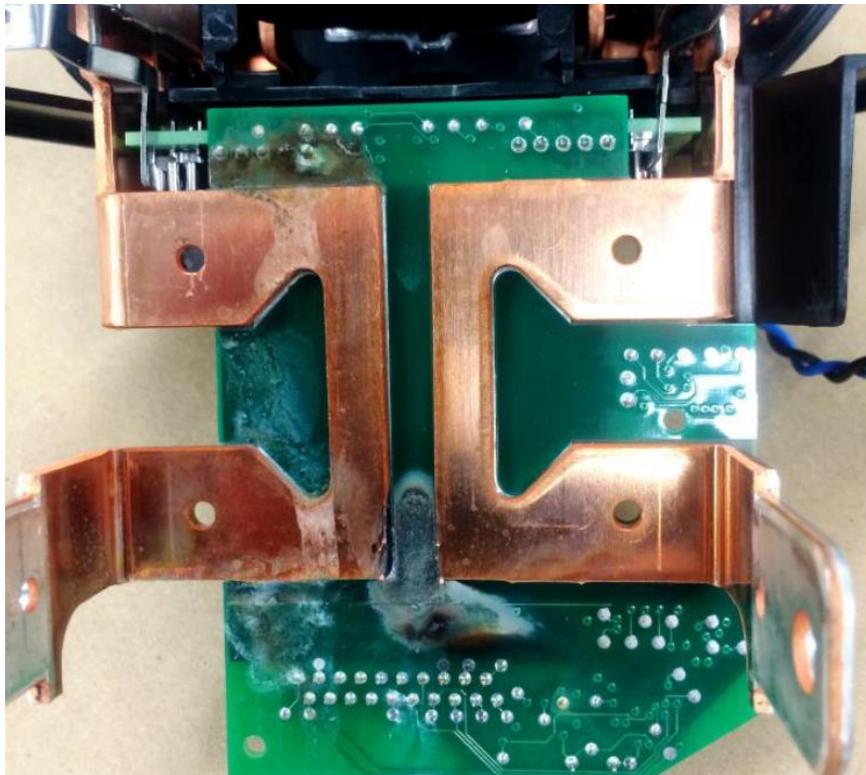
Figure 7: RMA Meter 1062400 – Moose Jaw – Reported as meter display problem

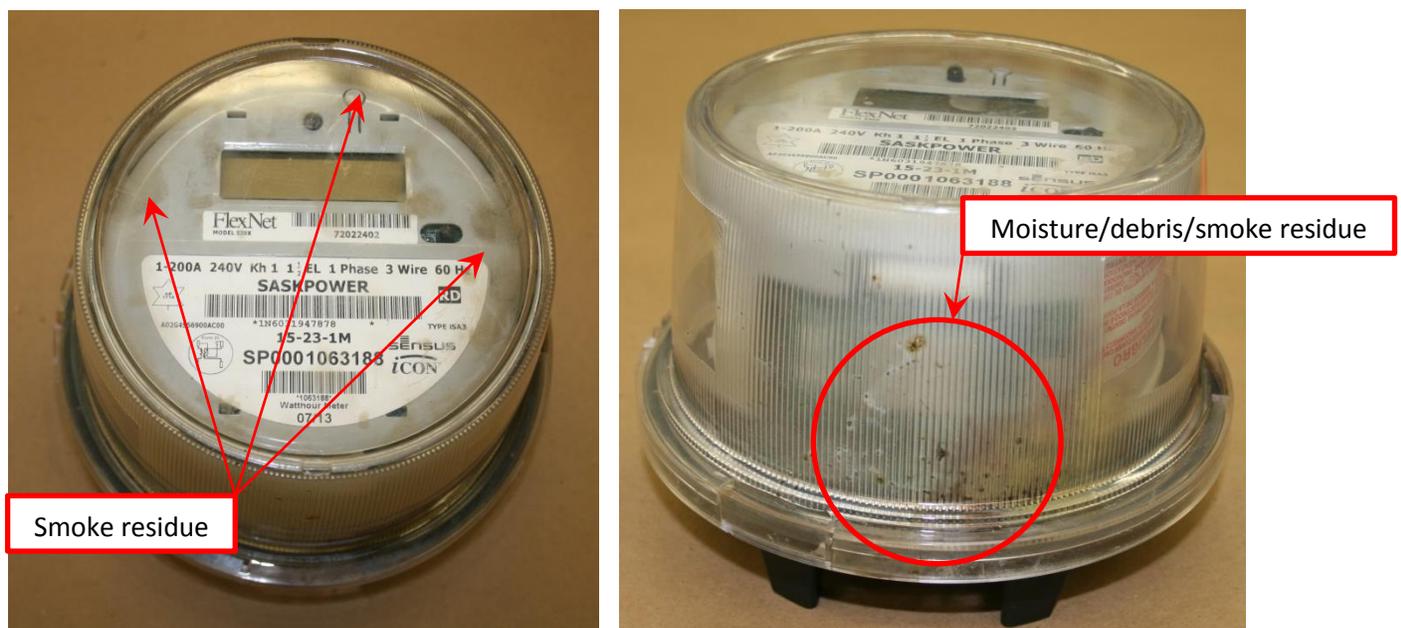
The following photo shows a meter that was returned through the SaskPower RMA process that has staining from smoke and evidence of moisture at the bottom of the meter.

Figure 8: RMA Meter 1063188: Located at NE 301597828 – Reported as burnt meter

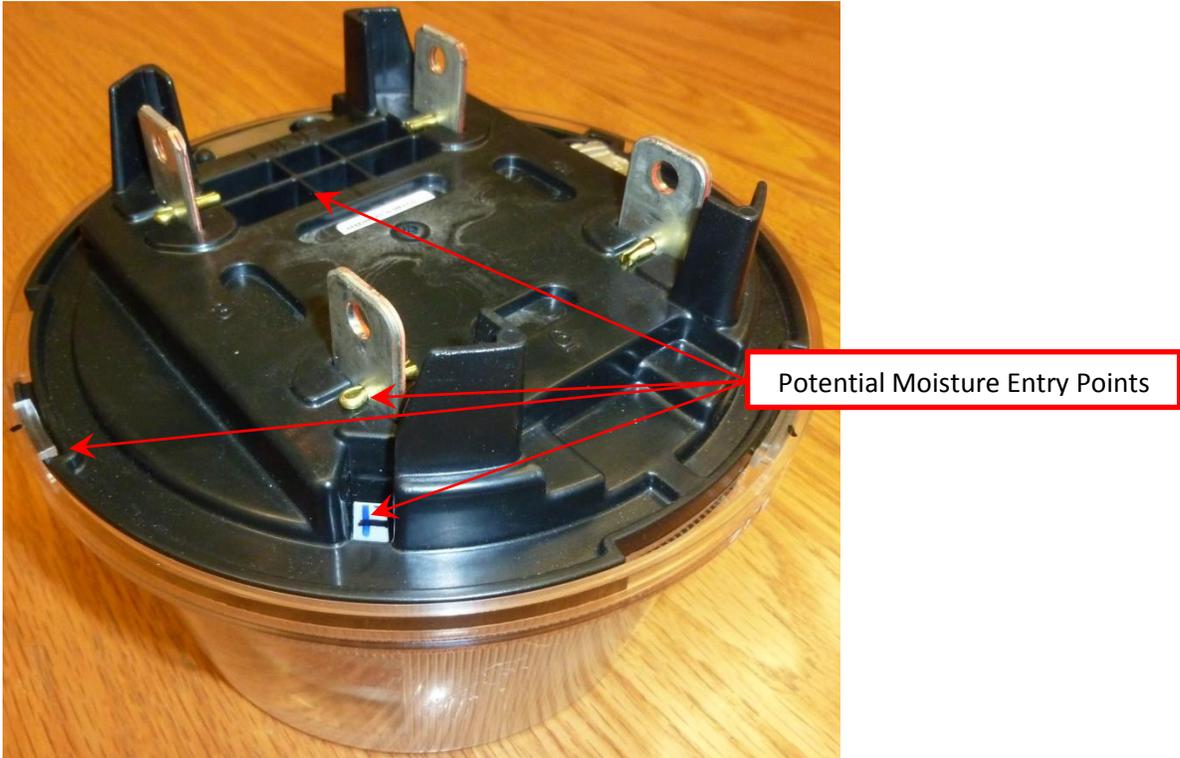
Figure 9: Backplane of Sensus meter

There is evidence that the Sensus Generation 3.3 meters are not very well sealed to keep moisture and dust out and includes the following.

- There is space around the stabs where they penetrate the back plane.
- There are several openings in the back plane which allow for the fastening of clips to mount internal components.
- There are several gaps in the clear enclosure cover where it meets the back plane.
- There is no gasket to seal the meter to the meter socket.

- When moisture is trapped within the meter, there is no path for it to drain away so the moisture and other contaminants remain inside the meter. This can also raise the relative humidity within the meter.
