Saskatchewan
Ministry of
Highways and
Infrastructure

HIGHWAY 35 AND HIGHWAY 335 INTERSECTION IN-SERVICE ROAD SAFETY REVIEW

Highway 35 & Highway 335 Intersection

Intersection Safety Review

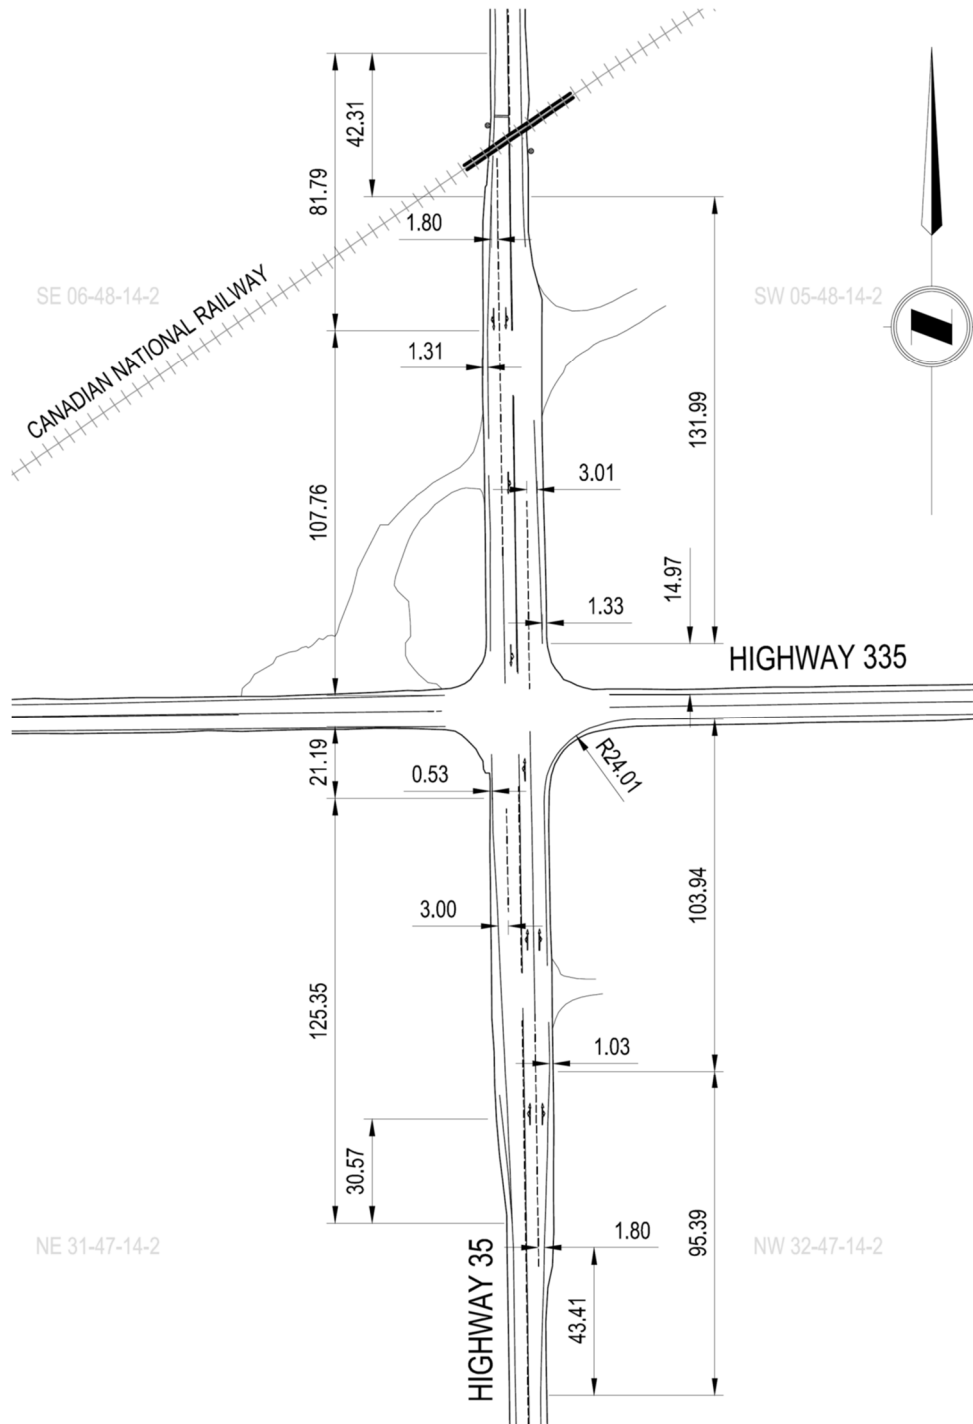
Figure 6-1: Highway 35 and Highway 335 Intersection Layout

As shown in Figure 6-1, the intersection has a flared treatment with the northbound and southbound through lanes being shared through/left-turn lanes, shared through/right-turn lanes develop through the intersection, including a transition lane downstream of the intersection. Highway 335, is stop controlled with single lane approaches in both directions.

Although the table indicates that some of the dimensions are shorter than recommended, the combined lengths are only marginally different.

In the northbound direction, the deceleration lane length is shorter than recommended. However, the combined deceleration lane/taper length is adequate, so the taper has just been painted a little longer than recommended. Similarly, the combined northbound transition lane/taper is only about 8m short of recommended, which is understandable given the close proximity of the railway crossing to the north.

In the southbound direction, the combined deceleration lane/taper is 10m shorter than recommended and the combined transition lane/taper is 8m shorter than recommended.

The deficiencies noted above are not significant enough to have a noticeable impact on traffic operations or safety.

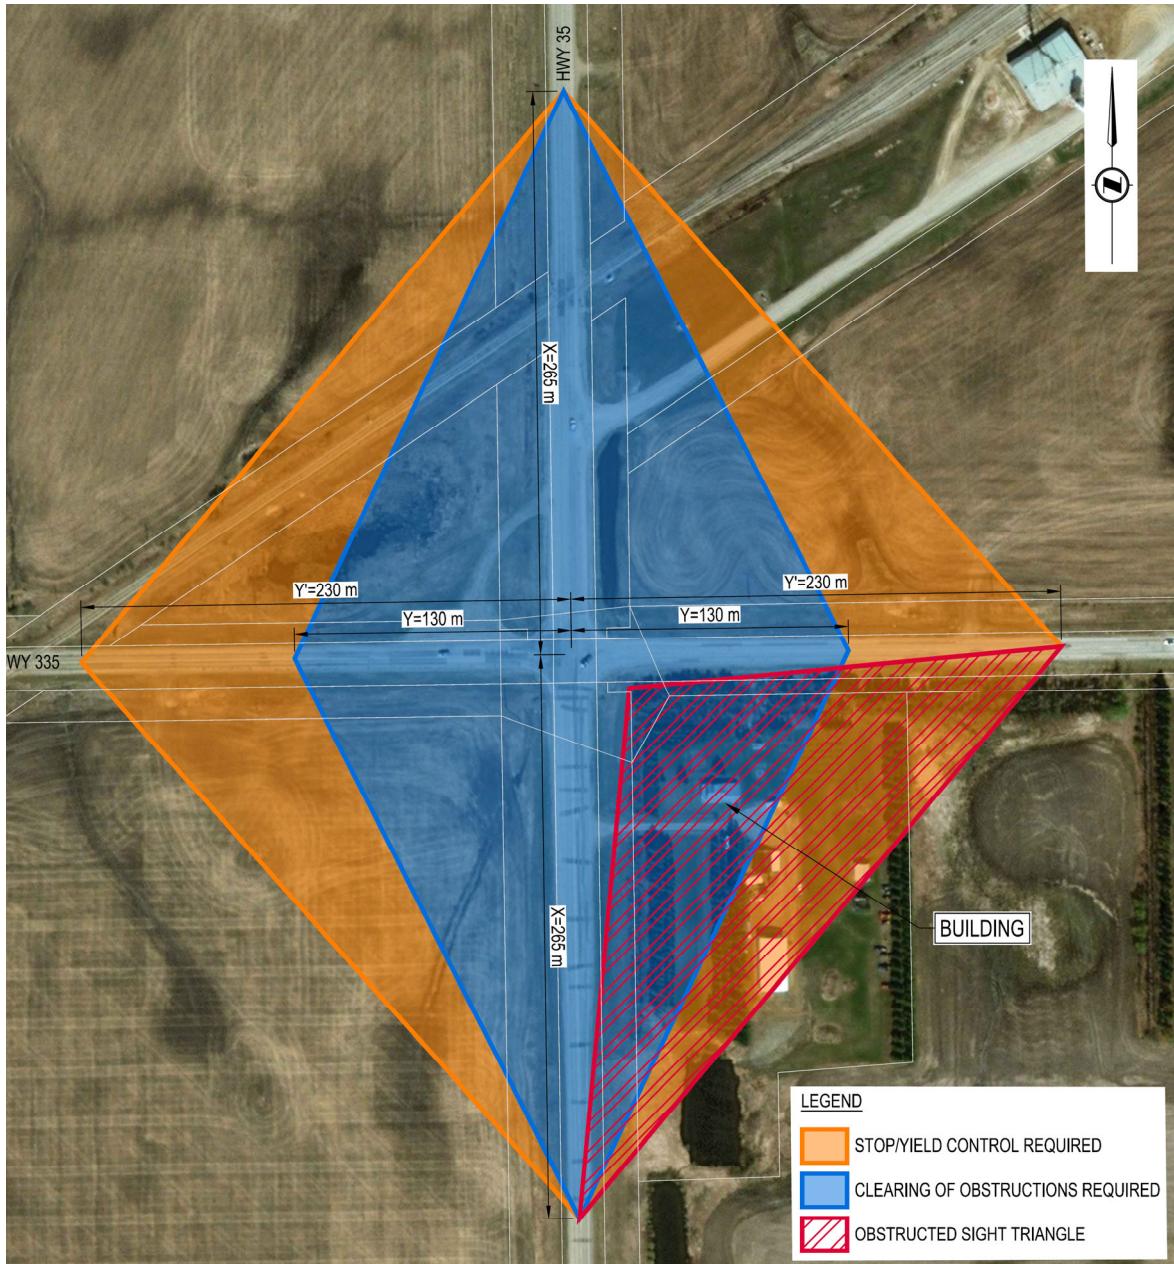
Figure 6-4: Intersection Sight Triangles (August 2018)

Based on the sight triangle review there are adequate sight triangles in the northeast, northwest, and southwest quadrants.

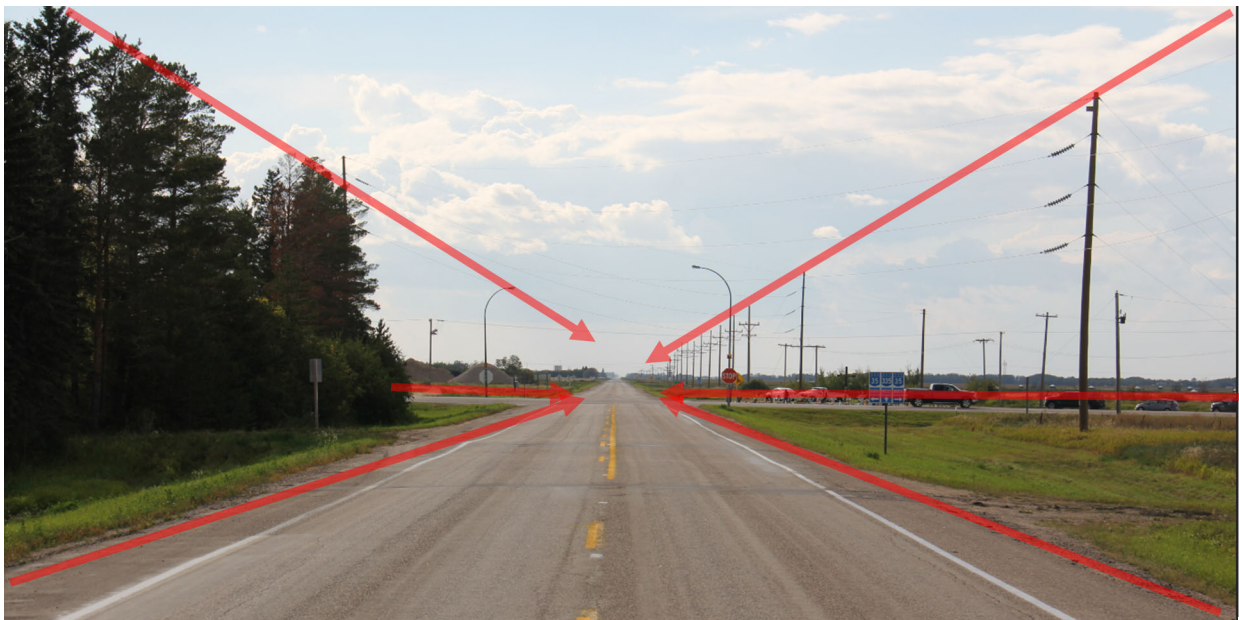
Figure 7-1: Tunnel Vision on Westbound Highway 335

There are some elements along westbound Highway 335 that could lead to tunnel vision. This includes the road alignment, horizon, trees, and power poles. As shown in Figure 7-1, this could focus motorist's attention to the centre of Highway 335 further west, which may result in motorist's overlooking Highway 35 and the stop sign. The illusion was observed to be even more pronounced during wet and/or sun glare conditions.

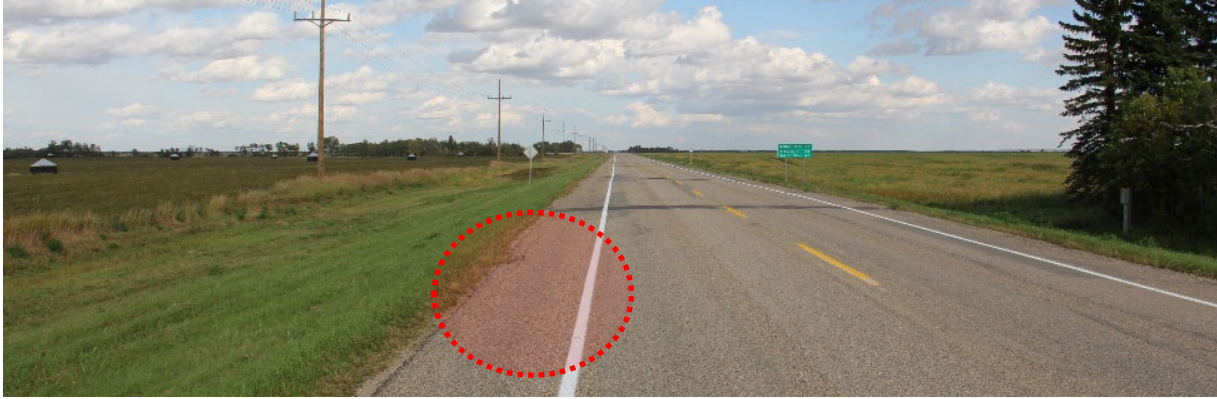
Issue Description
<p>The shoulder widths on both Highway 35 and Highway 335 are narrower than recommended. The shoulder widths are as narrow as 1.5m, where the recommended width is 2.0m.</p> <p>Shoulders provide a recovery area for errant vehicles and a refuge for stopped or disabled vehicles. Narrow shoulders decrease the effectiveness of the shoulders to achieve the above objectives.</p> <p>Five collisions over the past 28 years involved a run-off-road right movement.</p>
Issue Photo

Improvement Suggestions
<p>Mitigating this risk would require widening of the highway(s) to increase shoulder width.</p>
Improvement Costs
<p>The cost of implementation depends on the extent of the widening since this issue is not isolated to the intersection itself. The cost of shoulder widening is estimated at \$200,000 per kilometre per shoulder.</p>

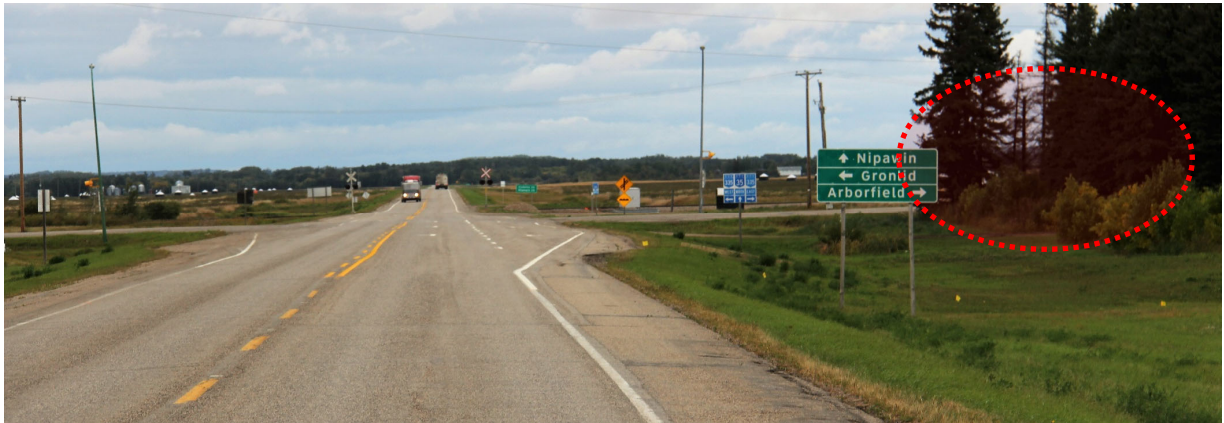
Highway 35 Northbound Approach (August 2018)

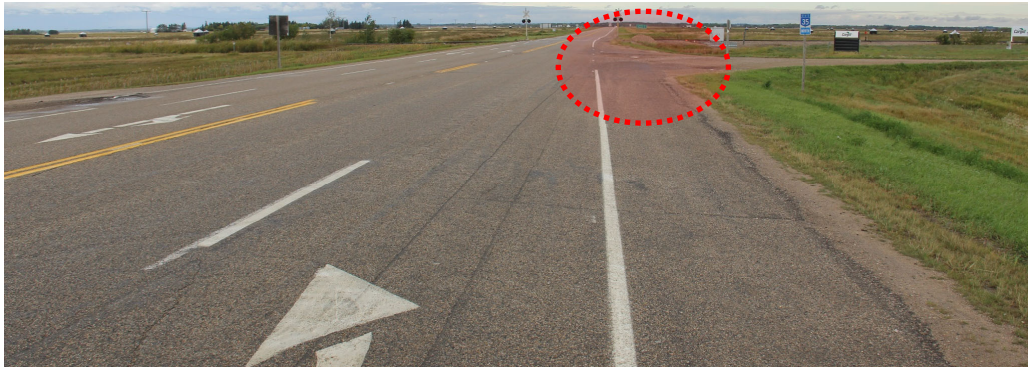
Highway 35 Northbound at Cargill Grain Elevator Access

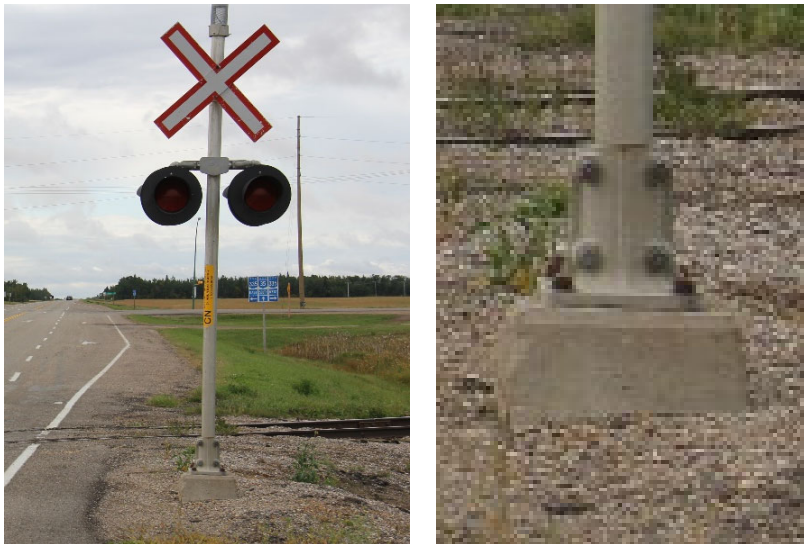
Railway Crossing Signals Within Clear Zone on Highway 35

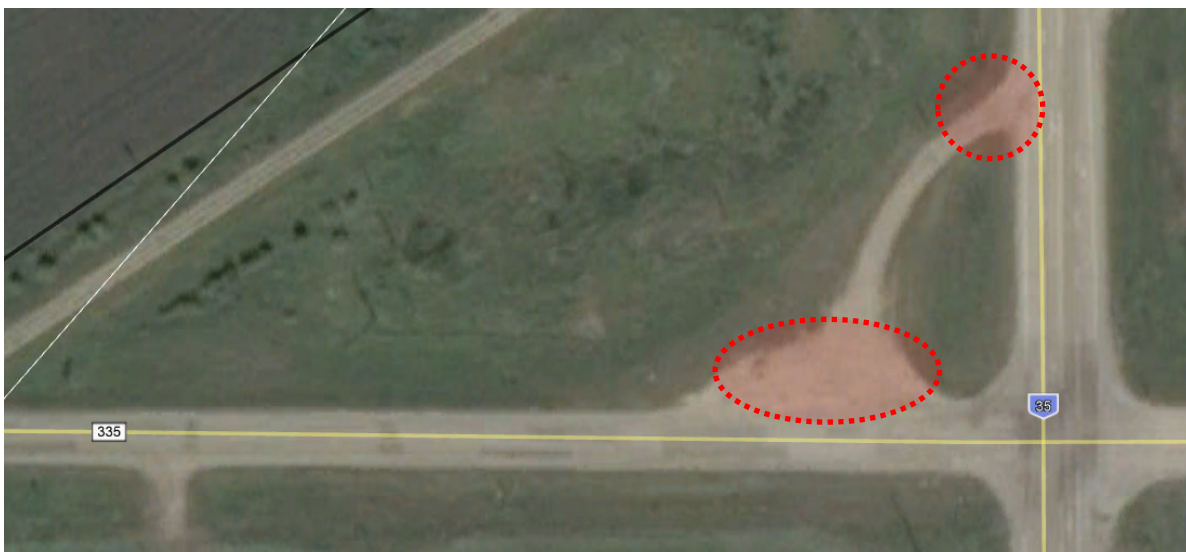
There is a gravel roadway / parking area located in the northwest corner of the intersection, which can be accessed via both Highway 35 and Highway 335. The parking area was present prior to the April 6, 2018 collision, but has since become the location of a roadside memorial. During the site visit, the memorial was observed to attract numerous visitors throughout the day. Furthermore, it appears that the parking area is regularly used by locals, possibly as a place to leave a vehicle when meeting and travelling with others. One or two vehicles were typically parked in the area during the daytime site visits.

Gravel Road in Northwest Corner of Study Intersection

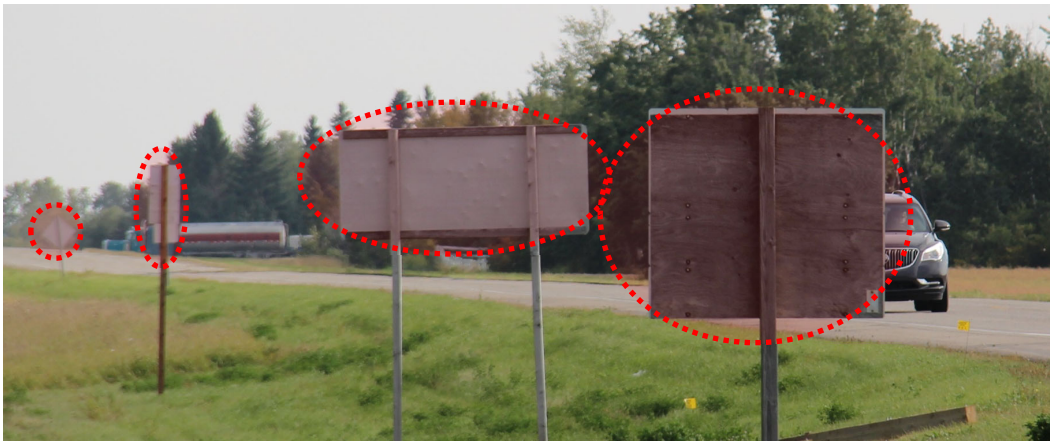
Highway 335 Westbound Approach Looking South

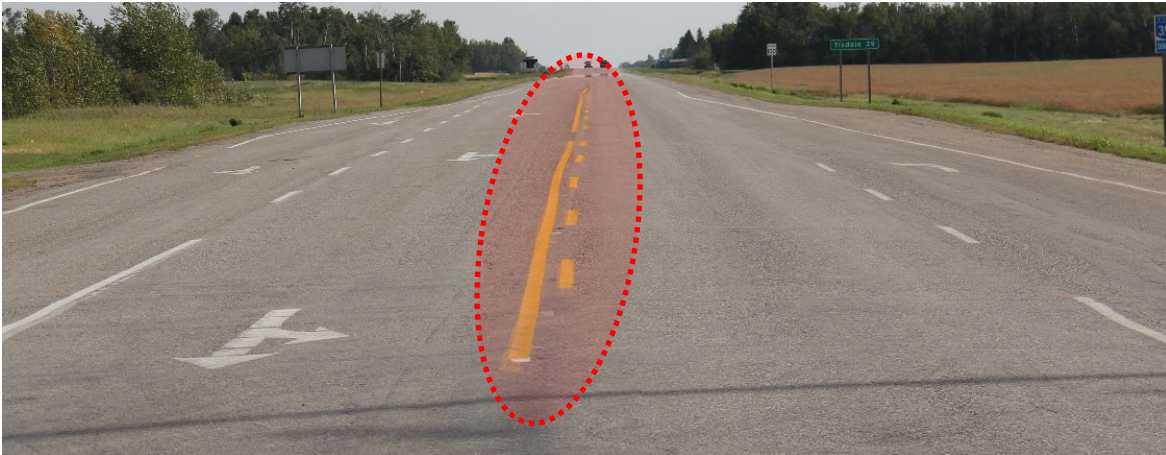
Highway 35 Looking South from Highway 335 Intersection

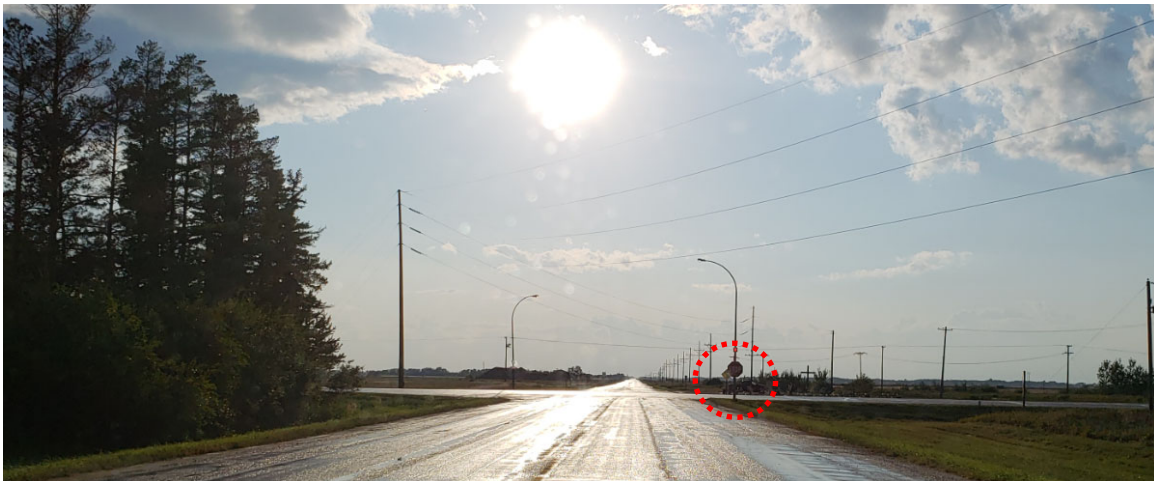
Westbound Highway 335 Sunset Glare Silhouettes Stop Sign (August 30, 2018, 6:15pm)
