Saskatchewan
Ministry of
Highways and
Infrastructure

HIGHWAY 35 AND HIGHWAY 335 INTERSECTION IN-SERVICE ROAD SAFETY REVIEW

Highway 35 & Highway 335 Intersection

Intersection Safety Review

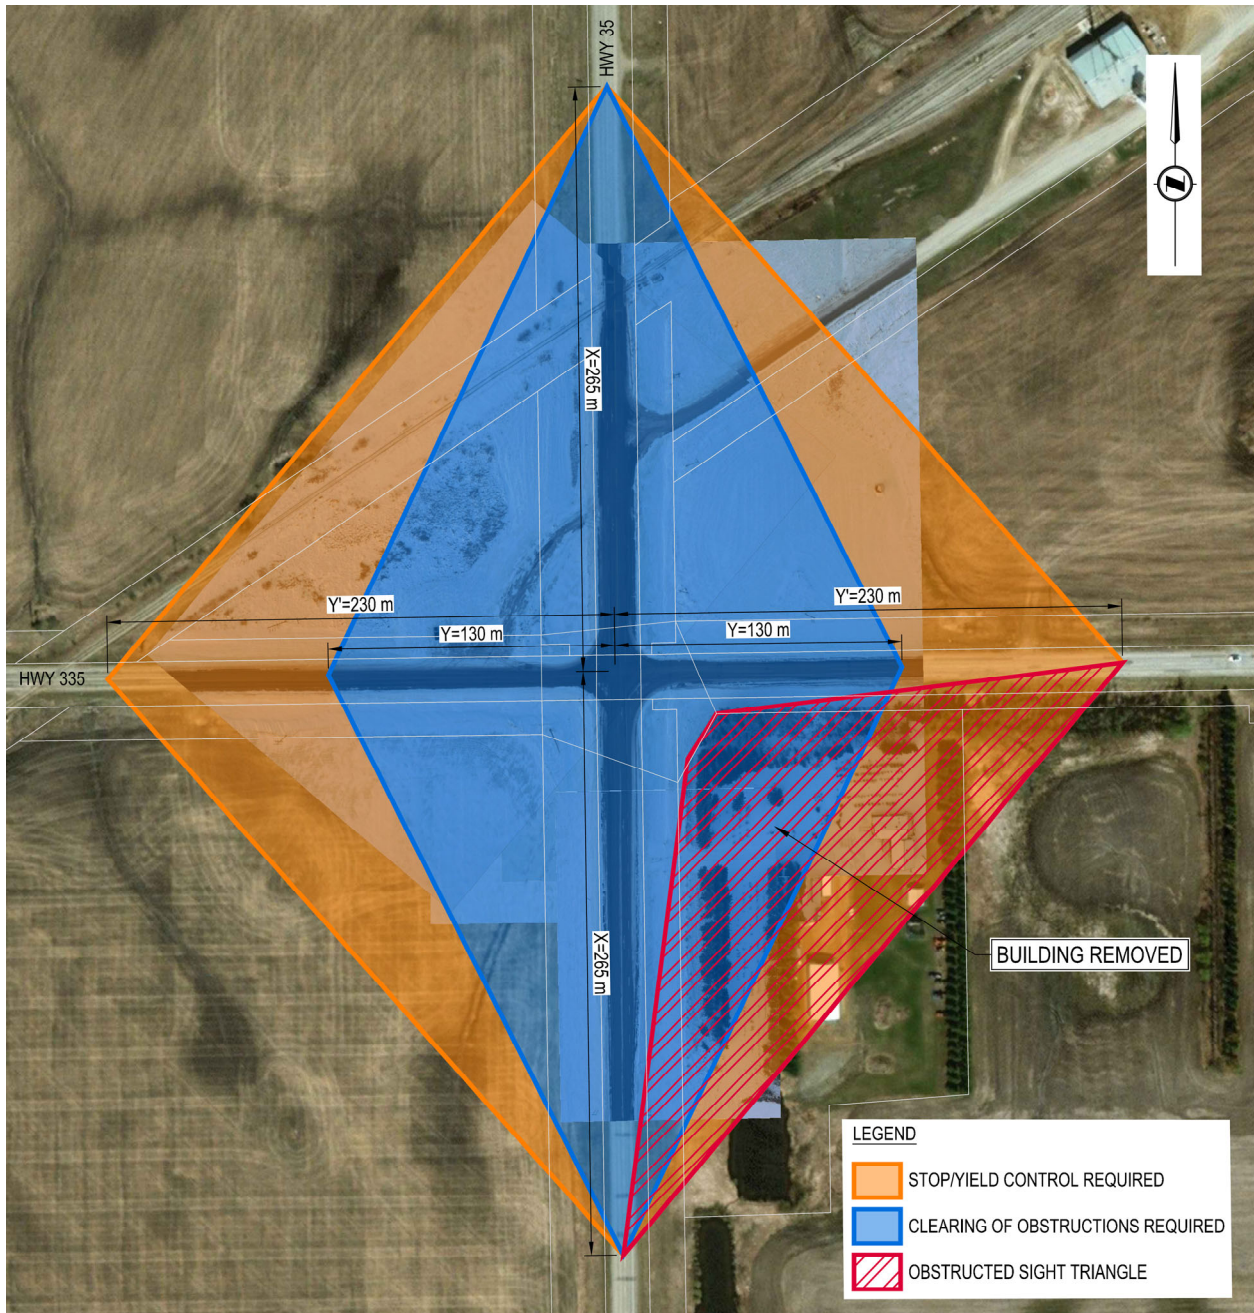
Figure 6-6: Intersection Sight Triangles (November 2018)

The \$20,000 for tree removal includes \$5,000 for trees within the MHI right-of-way and \$15,000 for trees on private property (not including property costs). In October 2018, MHI cleared the trees within their right-of-way. It was also identified at this time that the building in the southeast corner was removed or relocated outside of the sight triangle. An update sight triangle diagram is provided in Figure 6-6.

Approximately 400m² of trees were removed in the southeast corner of the intersection. The removal of the trees within the MHI right-of-way only marginally improves the sight triangle. On the northbound Highway 35 approach, it provides an additional 9.5m of visibility to the east at X=265m. On westbound Highway 335, an additional 7.1m of visibility to the south is provided at Y=130m.

The trees still remain on the private property in the southeast corner. However, the recent removal of the building in the southeast corner means that only trees would need to be removed in order to achieve the sight triangle, which would be significantly less expensive, but would still require negotiation with the land owner.

The sight triangle as identified in Figure 6-6, should ideally be cleared of obstructions. The cost is estimated at \$15,000 (4,000 m²). It is acknowledged that the costs associated with tree removal on private property may be cost prohibitive. Furthermore, there has only been one documented collision in over 28 years, which does not indicate a trend of collisions related to this issue. If clearing the obstructions within the triangle is not practical, stop control enhancements should be considered, the costs of which are discussed in Section 8.11.

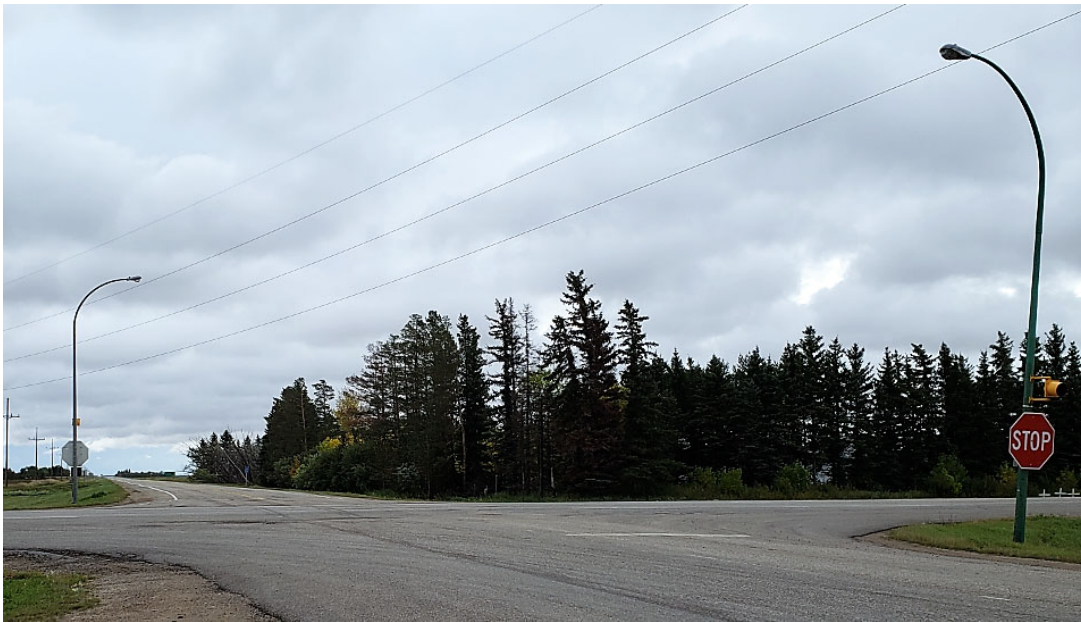
Figure 6-7: Highway 35 and Highway 335 Intersection Illumination

The intersection of Highway 35 and Highway 335 has delineation lighting as shown in Figure 6-7 and the lighting is consistent with Standard Plan 2621-1-1 (Figure 6-8). Based on MHI's *Traffic Control Devices Manual* (2007), Section TCDM 1102, the light standards should have break-away bases. Visual inspection could not confirm if the bases were break-away and should be confirmed by MHI.
