## **APPENDIX C – PlanGrid Task Report**

# PlanGrid Task Report - Aug 19, 2020

Prepared by James Holtom

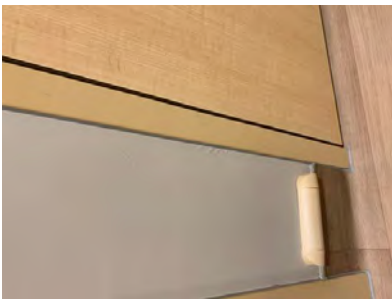
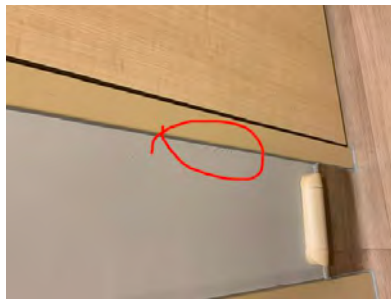
Screw missing within hinge of E2-152A.

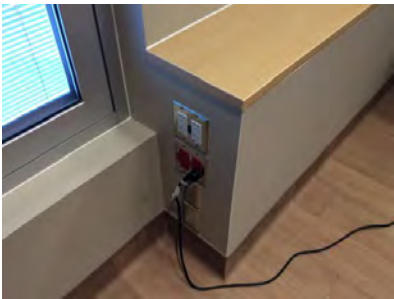
No corner guard, millwork counter not fitting correctly

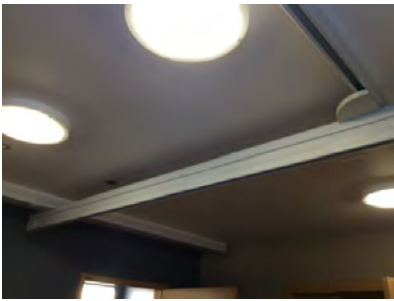
Potential ligature issue

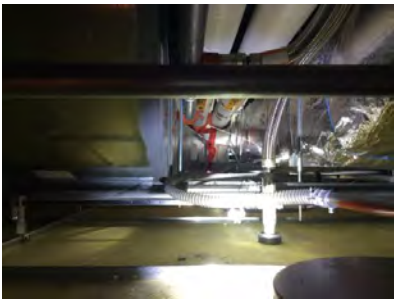
Red tape used for fire seal,  
appropriate material?

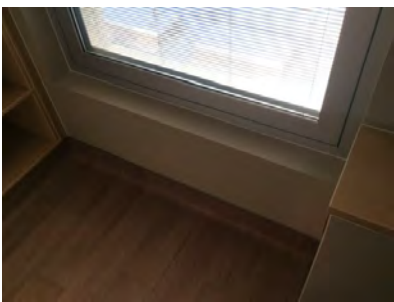
No window sill, check project requirements

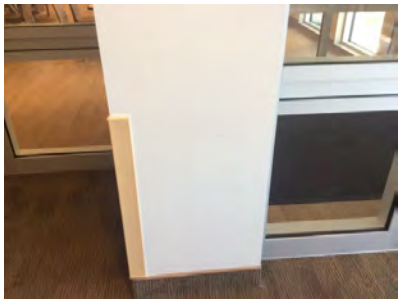
Description  
Appropriate wall protection?

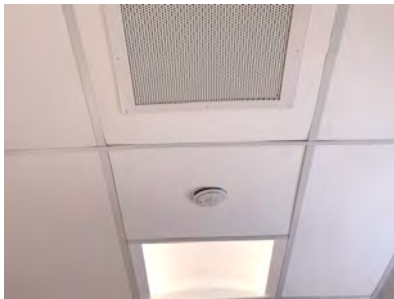
Sensor is loose. Ceiling tile is loose.

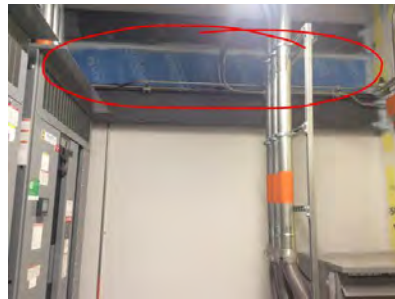
Confirm rating to this wall,  
membrane visible above beam

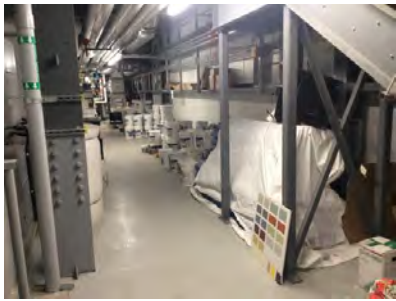
Paint and construction materials  
stored in mech penthouse

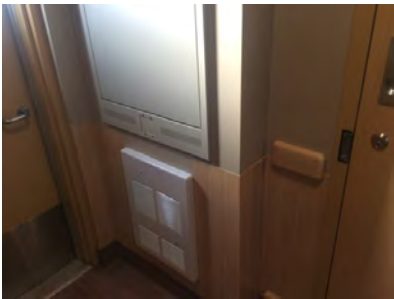
Not on drawings cru 1 & 2

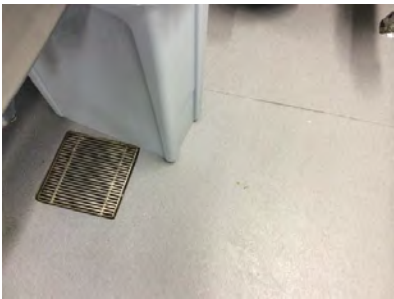
Flooring not sealed around grates. Welds broken.

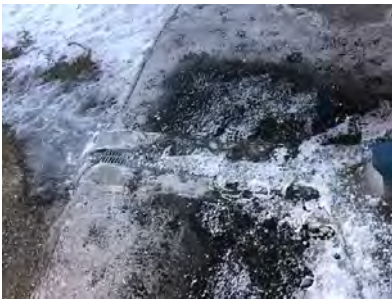
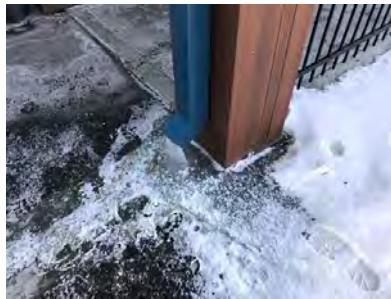
Rain water leader pours onto walkway. Drain system overflowing and creating ice.

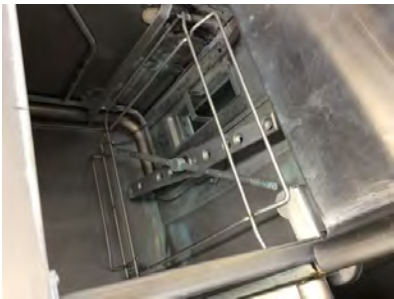
Excessive wear and tear on dishwasher and presumably other equipment

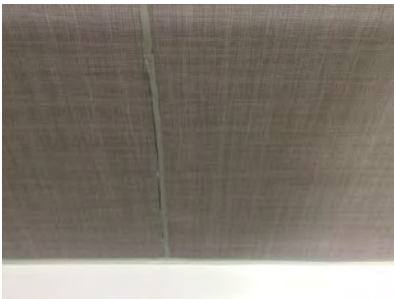
cru -1 Seams to wall finish  
failing

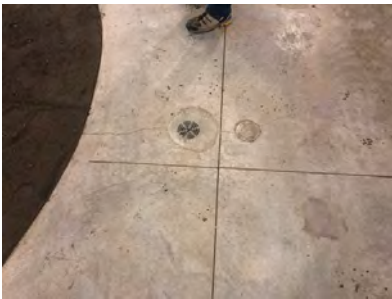
Sweat lodge. No flooring, being done by MCS. Is this tracked as a change or an original requirement? Concern on door thresholds to be flush with new flooring.

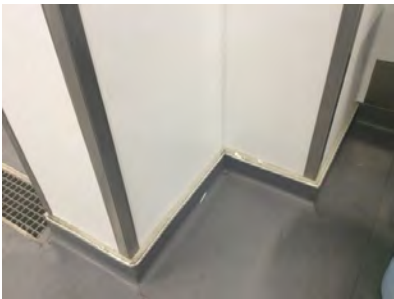
Pointless condition that collects dirt, possible infection control issue

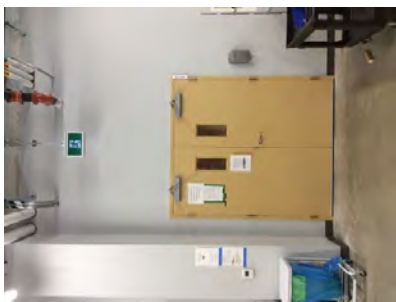
20200218\_181530\_photo

Doors appear to go in the wrong direction unless this room is assumed to have less than 50 people in it

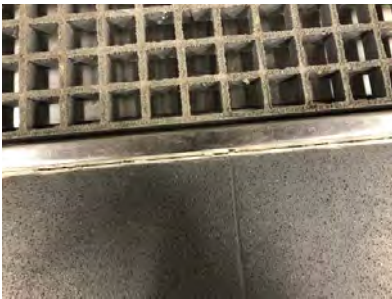
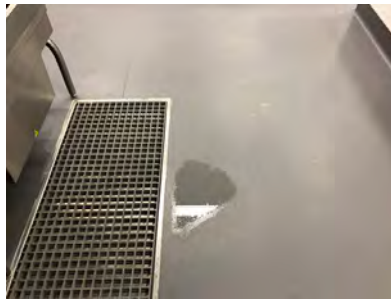
Pounding near grate. Uneven slope. Caulking is cracked.

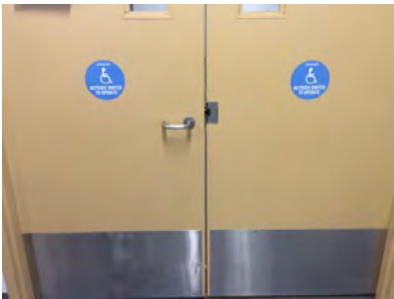
20200218\_182145\_photo

Gap in double doors

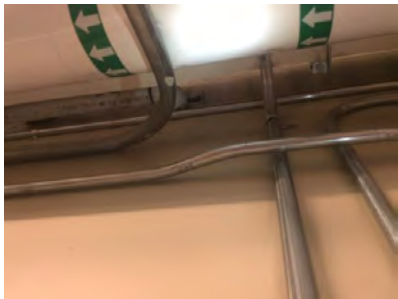
Description  
Fire caulking required

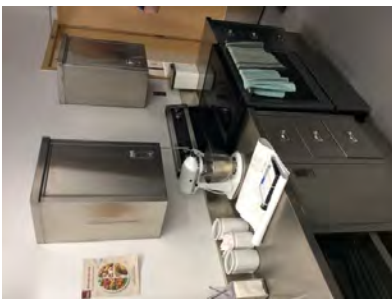
20200219\_081007\_photo

No exhaust hood, fairly well equipped kitchen in which I think there are some cooking activities which would generate grease laden vapours.

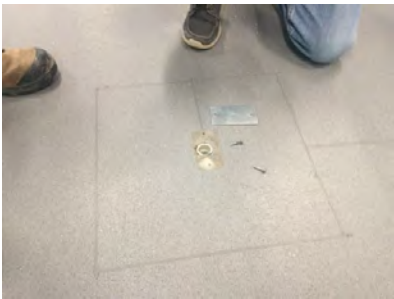
20200219\_082657\_photo

Loose floor plate cover, possible infection control issue

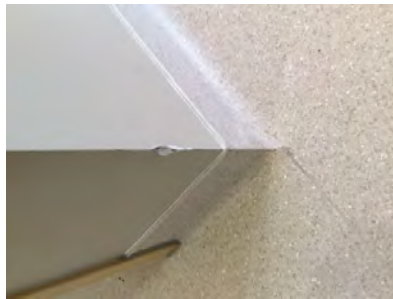
## #235 Architectural

No corner guards in the main reception area. Corners well abused.

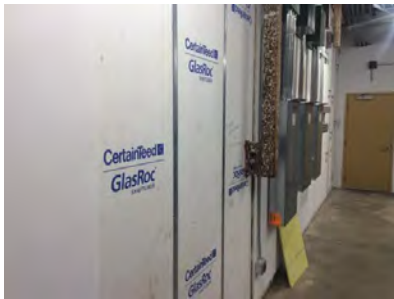
Shaft liner appropriate per contract requirements?

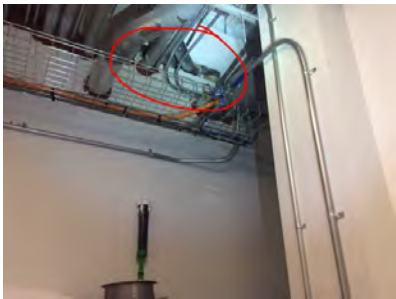
20200219\_090013\_photo  
James Holtom  
Feb 19, 2020 9:00 AM

Description  
Fire seal required

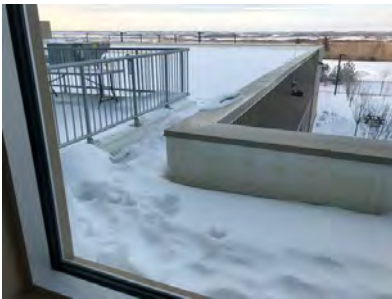
20200219\_090314\_photo

Roof access severely limited.  
Parapet is not high enough to be  
a barrier.

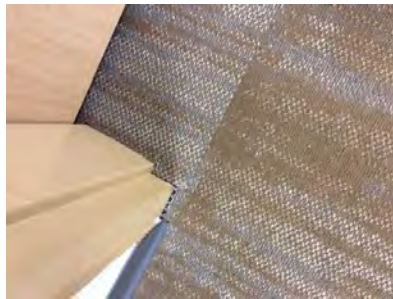
Confirm door hinge manufacturer is approved on submittal, middle hinge has no name tag noted, others are 'Lawrence'

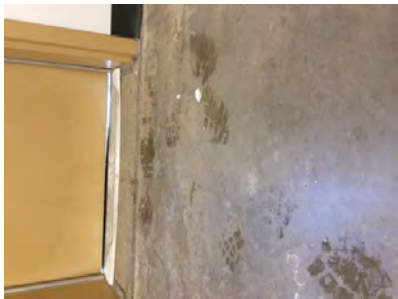
Location  
C1-026

Description  
Door sweep not touching.  
Operator noted mice are being caught in vestibule

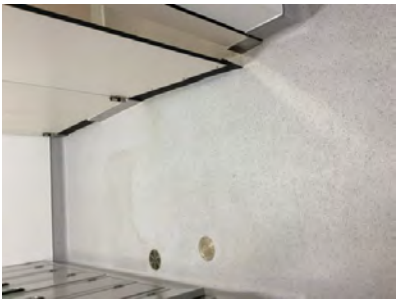
Location  
C1-039

Description  
Water pounding outside of showers, not making it to the drain.

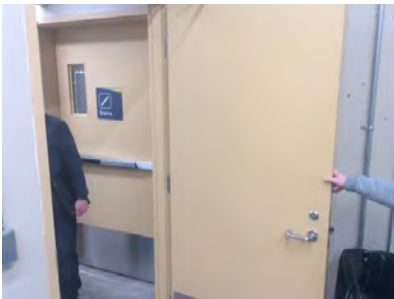
This wall and door should have a 1hr FR as this is a storage room. No rating to the door or frame

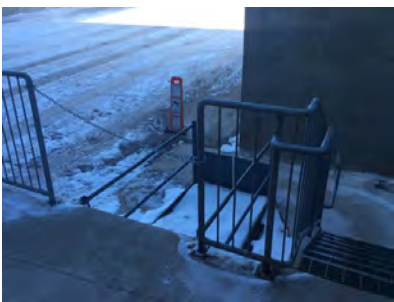
Lift is not accessible

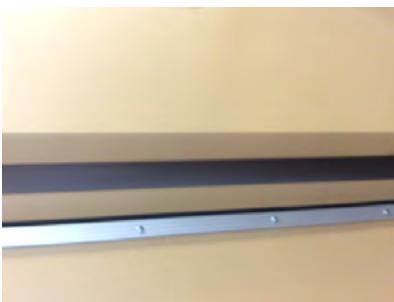
No stamp on door in rated wall

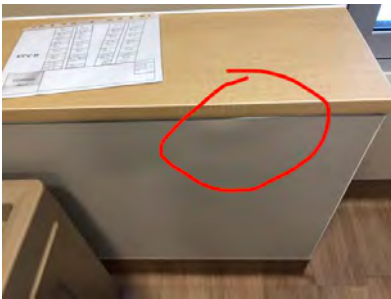
E1-481. Panel delaminating.

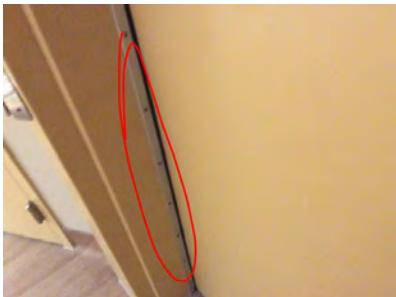
Description  
Acoustic seal not effective

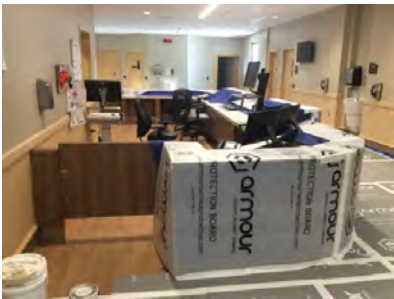
## #445 Architectural

Concern expressed by staff on the protection afforded to staff behind the wing reception

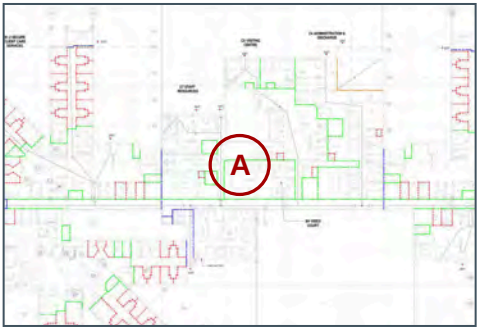
A00-03

No sound seals to these sound sensitive doors, typical to all video rooms. Poor acoustic isolation, acoustic treatments required to the walls of the video rooms

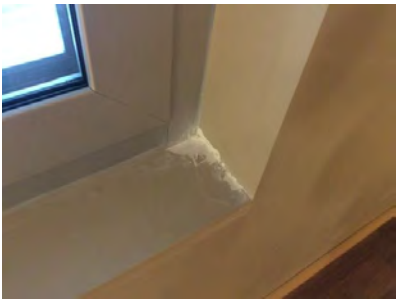
Sheet  
A00-03

Description  
Maybe evidence of damp

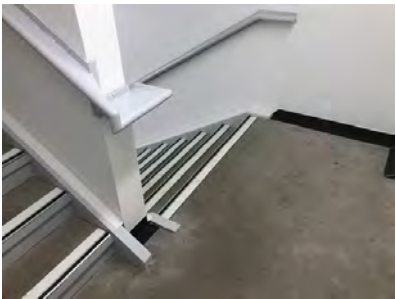
IMG\_2968  
James Holtom  
Feb 20, 2020 9:36 AM

Description  
Potential trip hazard

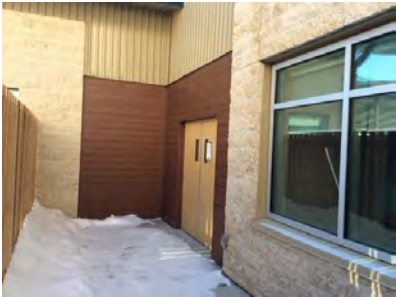
20200220\_103901\_photo  
**James Holtom**  
Feb 20, 2020 10:39 AM

Description  
No light over door

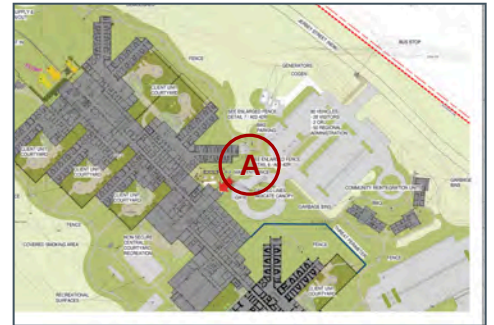
## #501 Architectural

Poor installation to concrete capping

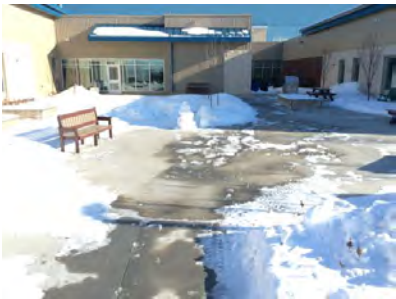
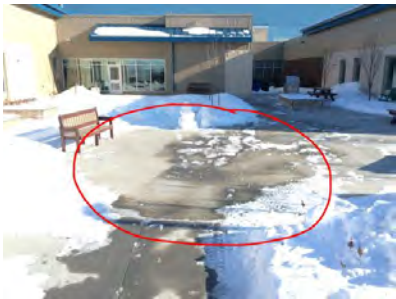
#510 Architectural

Description  
Lack of saw cuts, cracking evident

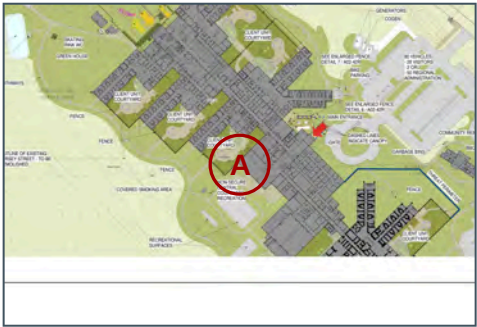
#511 Architectural

Description  
Concrete spalling

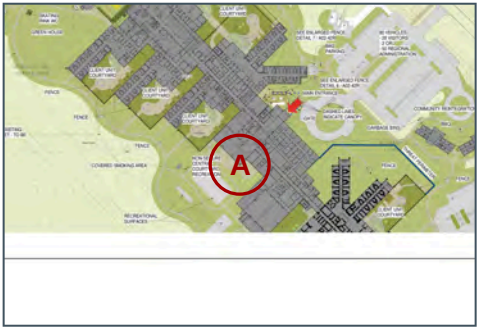
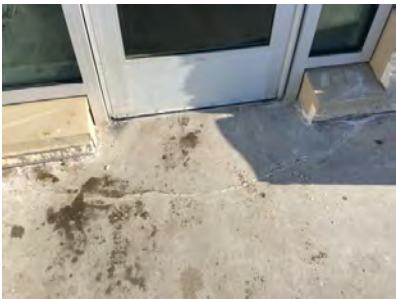
#513 Architectural

Description  
Poor quality ramp/transition  
creating trip hazard

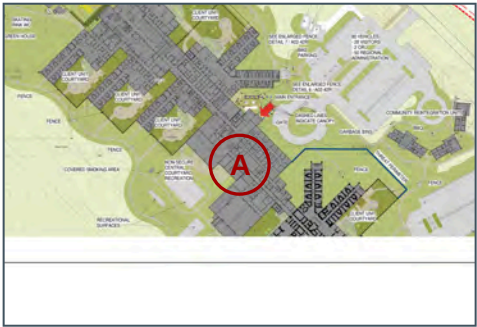
#514 Architectural

Description  
Confirm expansion gap  
requirement, some buckling  
evident to wall panels

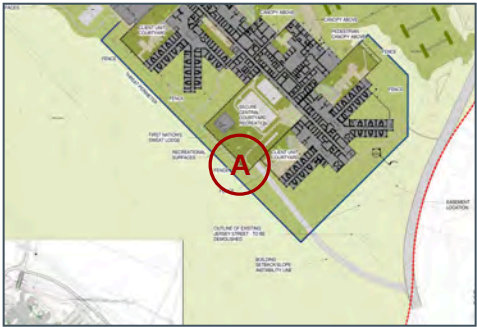
Sheet  
A01-03

Description  
Flashing sloped back towards wall

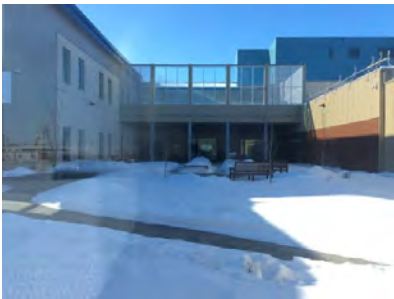
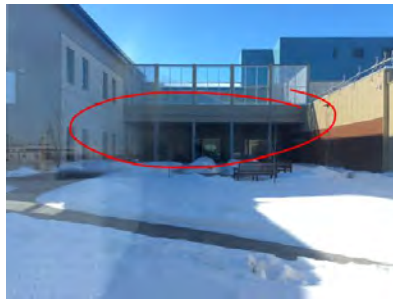
Sprinkler coverage required to overhang?

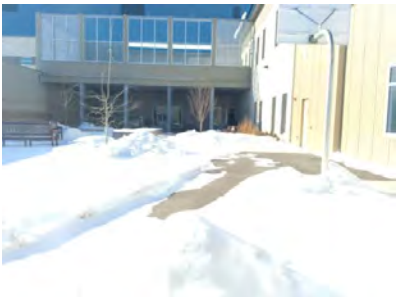
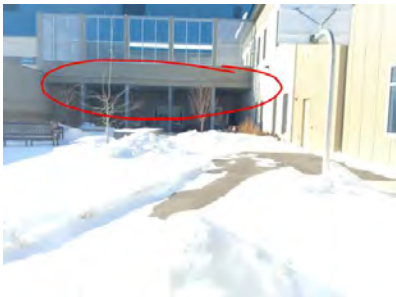
Sheet  
A01-03

Description  
Sprinkler coverage to overhang?

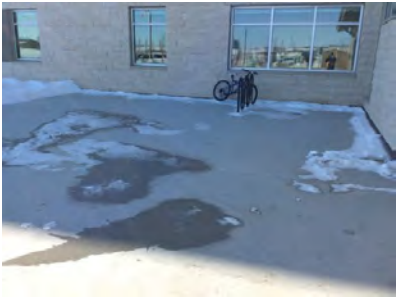
Sheet  
A01-02

Description  
Lack of saw cutting

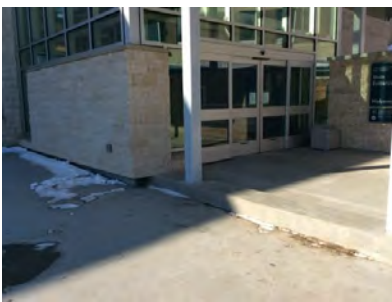
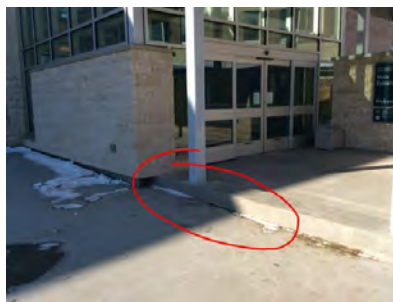
## #524 Architectural

Unconventional approach  
condition to the building

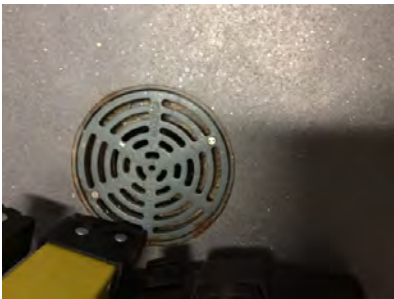
A00-02

Drain cover prematurely rusting

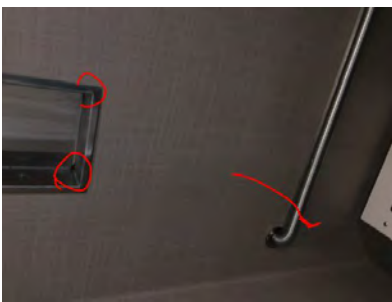
A00-02

Premature rusting on washroom accessories

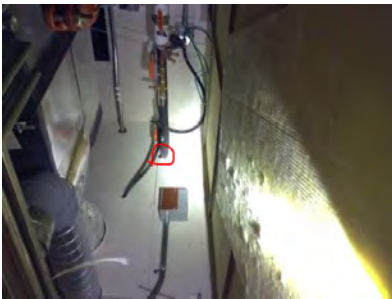
Fire seal appears to be missing on some penetrations through walls with FRR

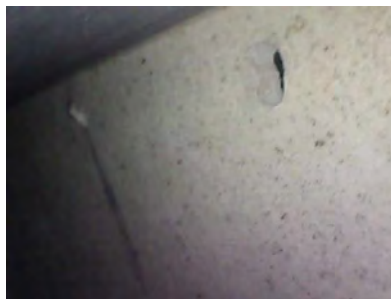
Exploratory hole near base of wall - daylight visible and draft indicating air leakage into wall cavity. Similar conditions likely exist all along this exterior wall based on thermal scans. Mould was also evident, as well as a small hole in the wall board.

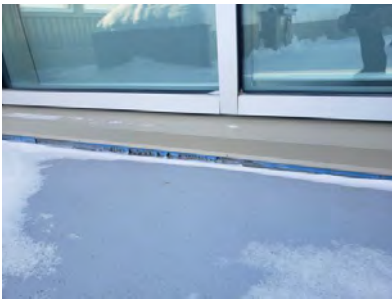
Exposed damaged Blueskin noted along base of wall above balcony deck

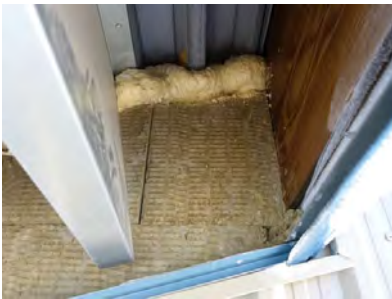
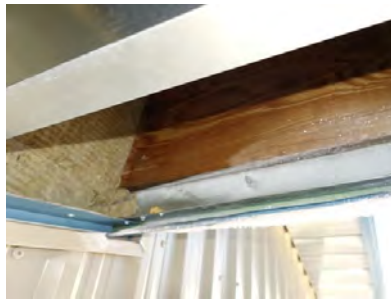
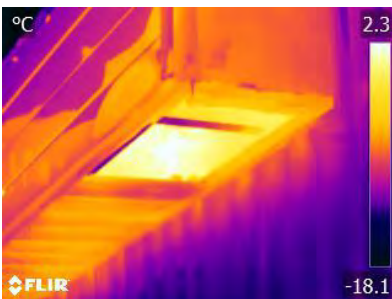
Air leakage between top of exterior wall and sloped roof, resulting in wet surfaces inside soffit. Frost also visible on exterior metal surfaces

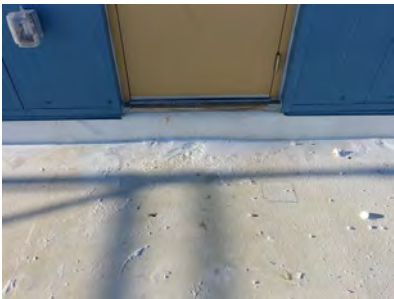
Sheet  
A00-07

Description  
Missing sill flashing below  
exterior door above roof

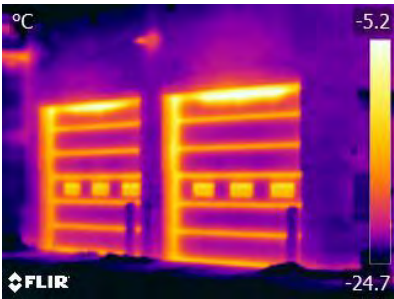
Sheet  
A00-03

Description  
Air Leakage above overhead doors

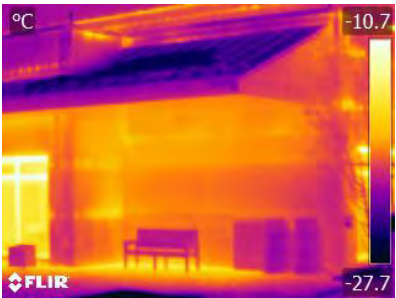
Thermal anomalies in exterior walls and location of exploratory opening on interior at wall junction

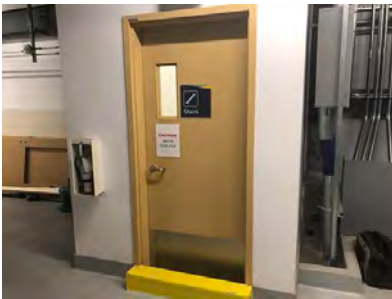
## #272 Electrical

Penthouse - Fire alarm pull stations are in small vestibules and not main penthouse. Not best practice, but technically not in the stairwell.

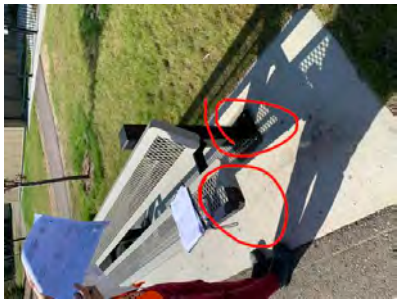
Sheet  
A01-02

Description  
Furniture is deteriorating and rusting. Bench centred and not accessible.

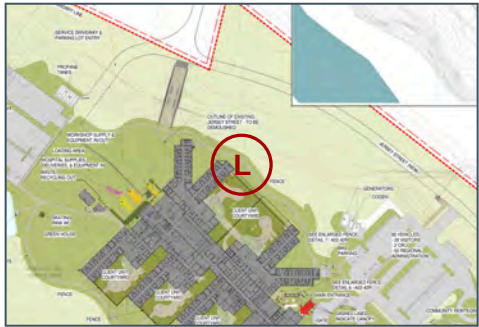
Sheet  
A01-02

Description  
Different bench styles.

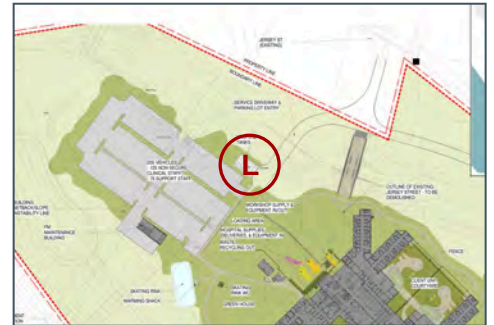
Location of propane tanks differs from plans. Not aligned with layby. Fence around propane tanks?

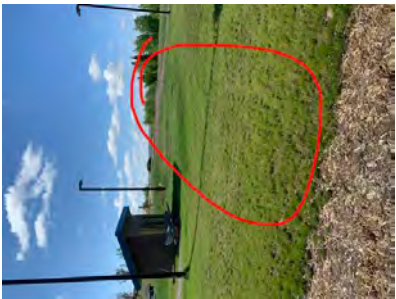
Sheet  
A01-02

Description  
Missing rink?

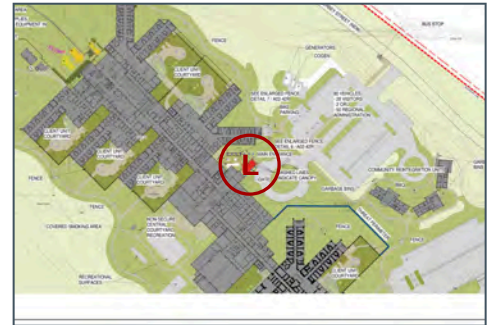
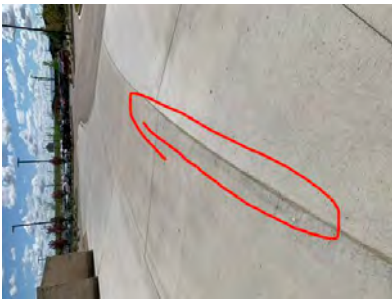
A01-02

Tripping hazard.

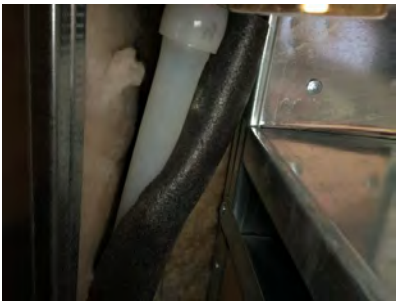
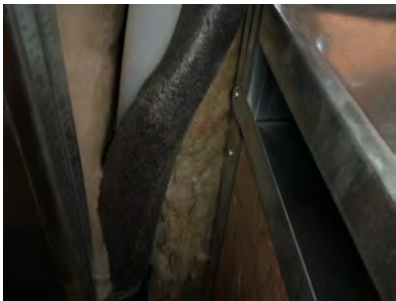
Sheet  
A00-05

Description  
Access panel outside E2-450.  
Pex insulation not on properly.

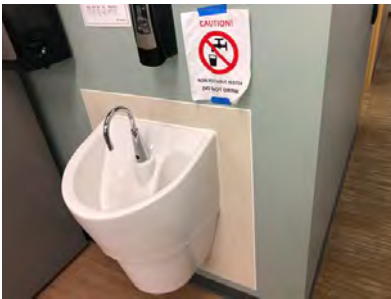
Sink has too much pressure.

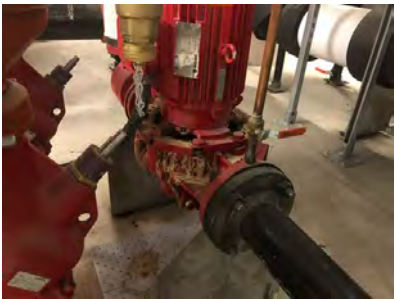
#230 Mechanical

Description  
Penthouse - Corrosion of line.  
Unsure if its purpose.

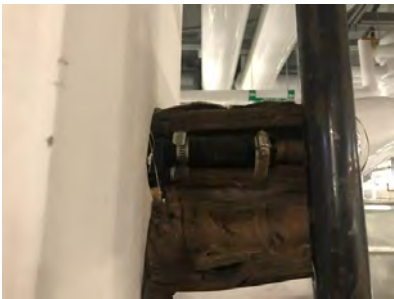
#232 Mechanical

Description  
Penthouse Outside - No  
isolation on dry coolers.

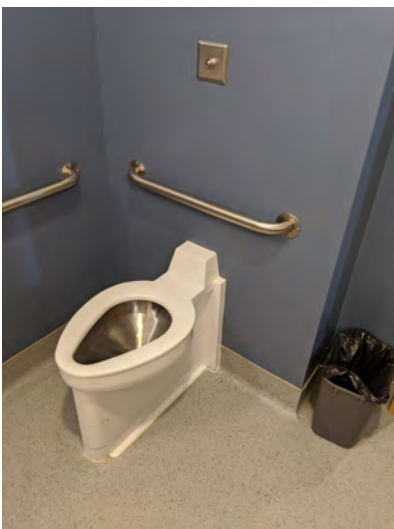
Pipes rattle when vacuum toilet flushed. Piping not secured enough. Not as bad as other unit.

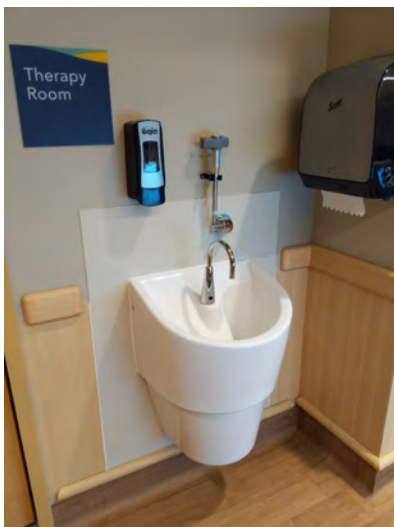
## #417 Mechanical

Hand wash faucet was warm.  
Thermostatic mixing valve  
setpoint.

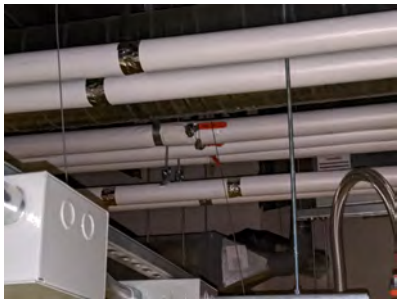
Description  
Domestic hot water recirculation  
turned off

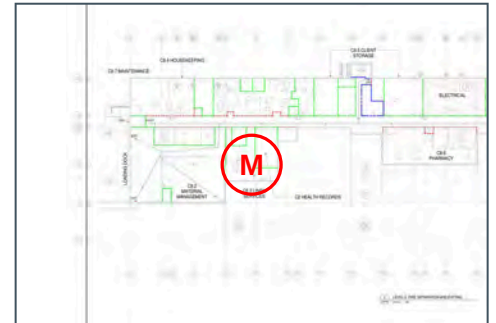
IMG\_20200220\_131206.jpg

No provision for makeup air of dryer exhaust. Dryers draw air from general ventilation system.

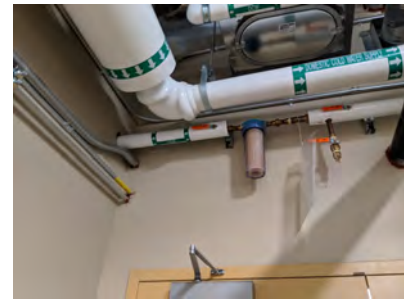
No backflow preventer for domestic cold water lines serving sanitary vacuum system.

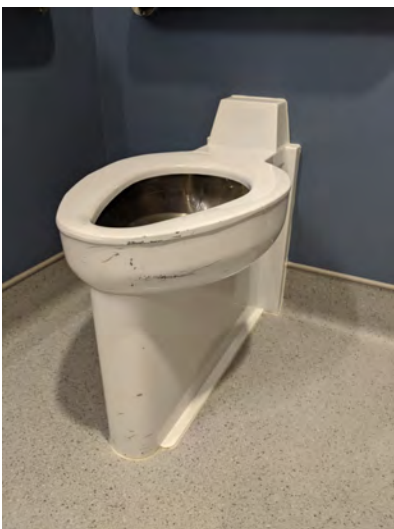
IMG\_20200219\_124733.jpg

Vacuum water closet valve takes extended time to close. WC visibly scuffed / damaged.

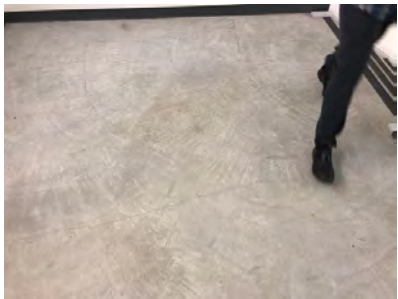
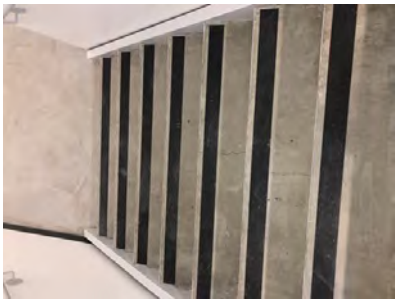
Sheet  
A00-05

Description  
Stairwell. Many cracks. Poor workmanship. Concern on rough finish and ability clean. Raw concrete.

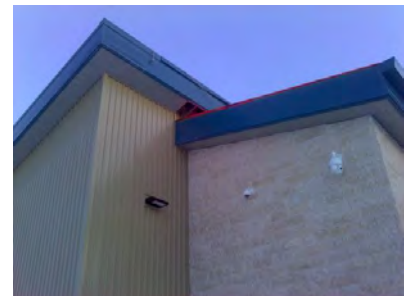
Frost on metal soffits and fascia
